**CB RADIO**

**Service Manual AE 6890**

## Technische Mitteilung zu AE 6890

## Technical Information AE 6890

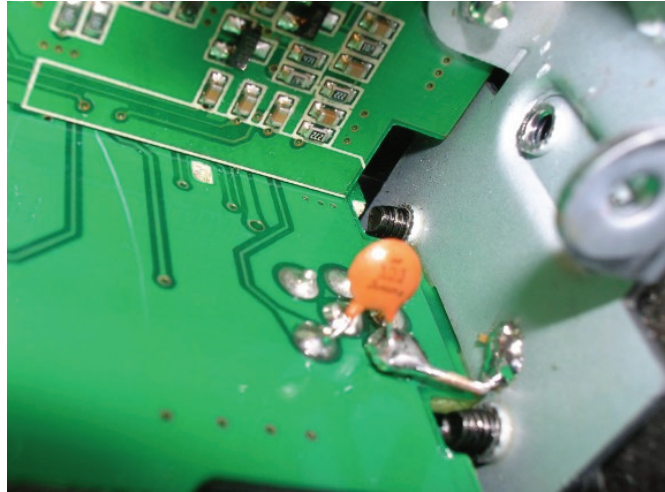
**Problem:** Bei Montage einer schlecht geerdeten Antenne oder einer Antenne mit schlechtem SWR sehr nahe am Funkgerät im LKW kann es vorkommen, dass das Sendesignal vom Mikrofonskabel aufgenommen wird und die Modulation gestört wird (das Ergebnis sind starke Verzerrungen in AM).

b) **zusätzlichen Kondensator 103 = 10 nF bzw. 0.01  $\mu$ F** nach Bild direkt an der Mikrofonsbuchse zwischen Pin 1 und Masse einbauen

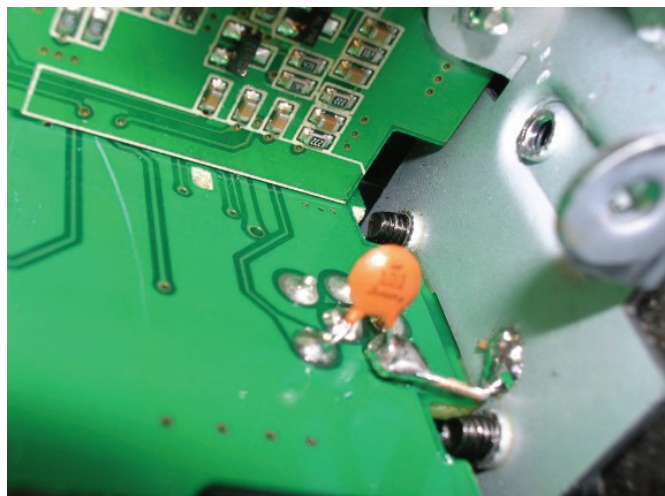
**Problem:** If the antenna is mounted in a truck installation very close to the radio, has a bad grounding or a bad SWR, it may happen that RF energy will be picked up by the microphone cable. The consequence can be a distorted modulation quality in AM.

b) **add a capacitor 10 nF = 0.01  $\mu$ F** (printing 103) inside the radio as shown on the picture. The capacitor shall be soldered directly to pin 1 of the mic socket and ground as shown on the photo.
